BRAINERD ROTARY CLUB

Rotary Riverside Park Update

DATE: October 1, 2019

Rotary Park Entrance Project Update:

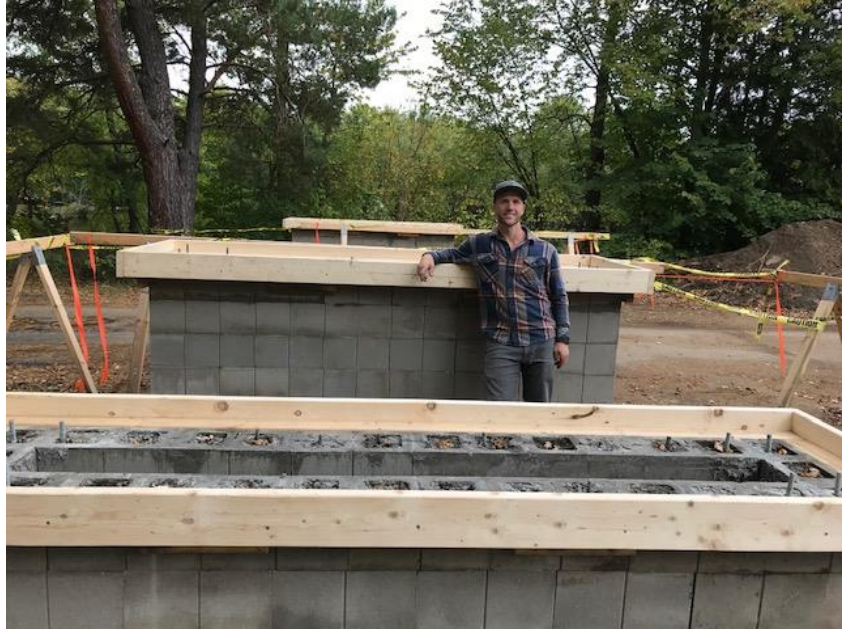
Friday September 27 the cap forms for the final concrete pour were put in. These define the final dimensions on which the supporting posts will be located. The final pour may not be until the week of October 7 due to weather and availability of the weldments. This was completed by Pete Nelson and Morgan Gobely.

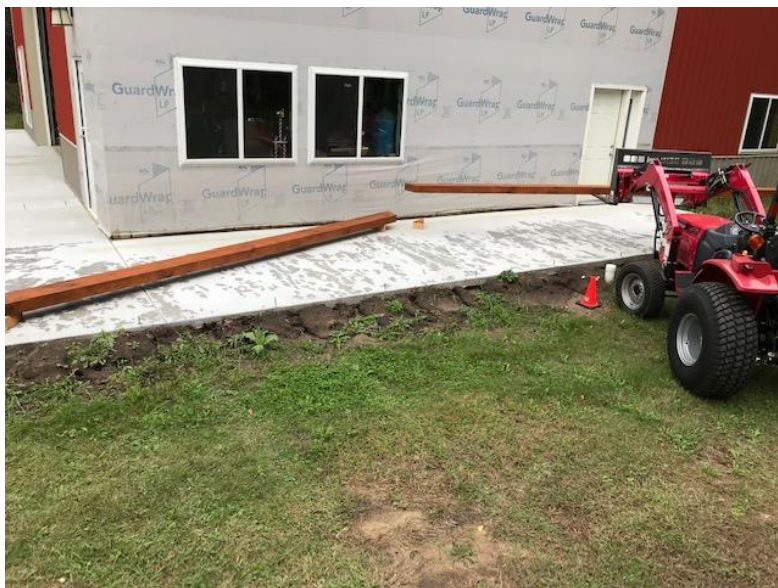
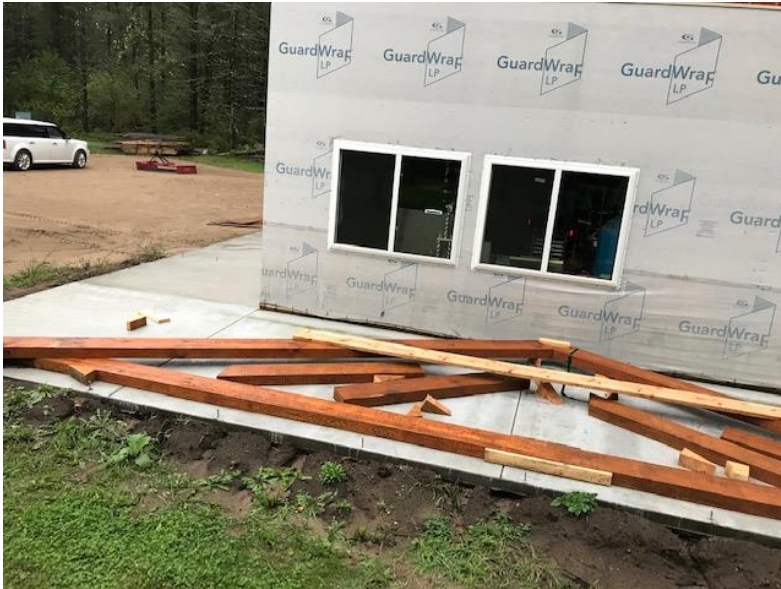
On Saturday September 28 the timber truss assembly is underway.

Assembling a truss is a lot of detail cuts to assure joints are tight. Truss material is full dimension 4X10 red pine. The truss is assembled using construction lumber (2X4 & 2X10). After preliminary assembly the steel joining plates are added to make the permanent assembly that will be raised into place.
